Appendix I

Vegetation Observations

A visual inspection of shoreline vegetation along the upper reach of the Lower Duwamish Waterway was conducted by boat on June 20 and July 1, 2021, as part of the Phase II Pre-Design Investigation (PDI). This inspection built on the information collected during the PDI Phase I visual bank inspection but focused on areas where remediation is anticipated to occur. The inspection included the collection of photographs and detailed observations to document shoreline vegetation within the Phase I remedial action level (RAL) exceedance areas along the upper reach. During the planning phase of the program, periods of predicted daytime moderately low tides (i.e., low enough to observe bank conditions while still being accessible by boat) were identified as potential survey dates, and actual inspection dates were selected based on forecasted weather conditions and team availability.

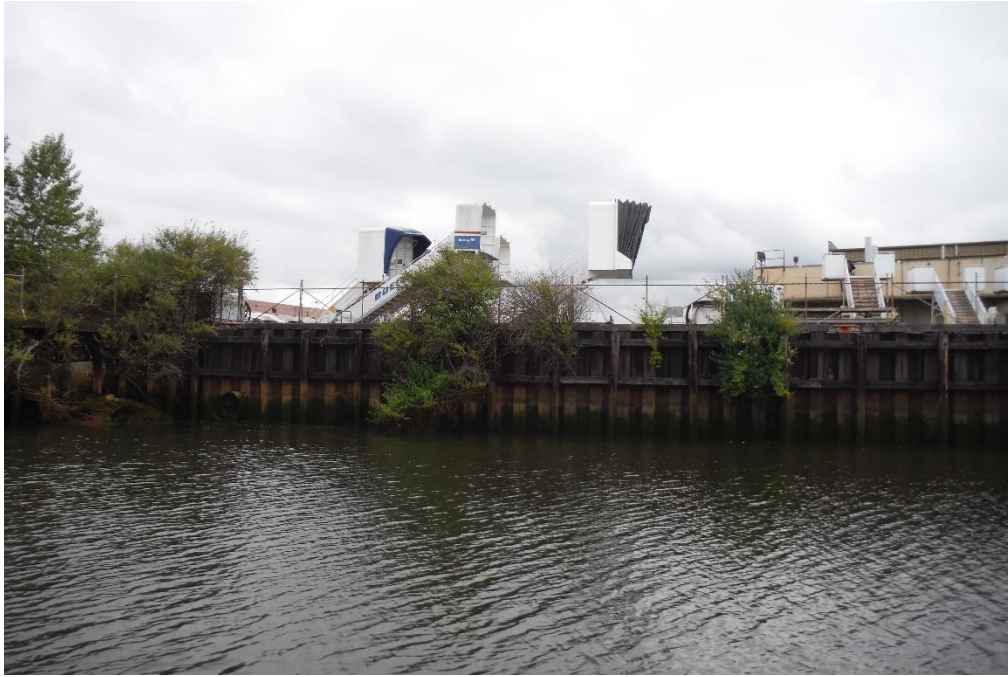
Photograph I-3
Representative Vegetation Conditions at RM 3.8W-b

River Mile ¹	Location Along Bank	Substrate/ Structure	Species	%	Notes
3.8E-b	Top of bank	Sheetpile wall	BUDA	5	Sparse vegetation
	Middle of bank	Sheetpile wall	-	-	No vegetation
	Toe of bank	Gravel and fines	-	-	No vegetation

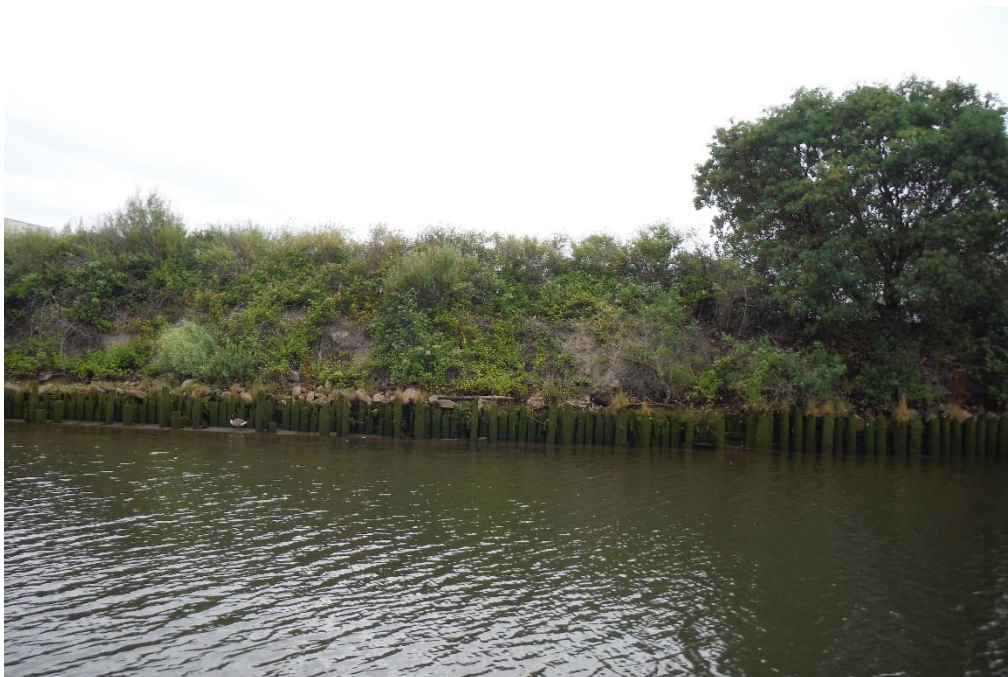
Photograph I-4
Representative Vegetation Conditions at RM 3.8E-c

3.8E-c	Top of bank	Eroded wooden bulkhead with layers of fill and soil	BUDA	60	Vertical slope of eroding fill
			RUAR	10	
			RULA	10	
			ARME	5	
	Middle of bank	Eroded fill from top of bank, 45% of the slope	RUAR	45	Middle of bank held in place by downslope eroded bulkhead
			LELA	5	
			BUDA	5	
			POPA	5	
			FRLA	5	
	Toe of bank	Rock, gravel, and fines	SYLA	5	Aster growing within bulkhead piles

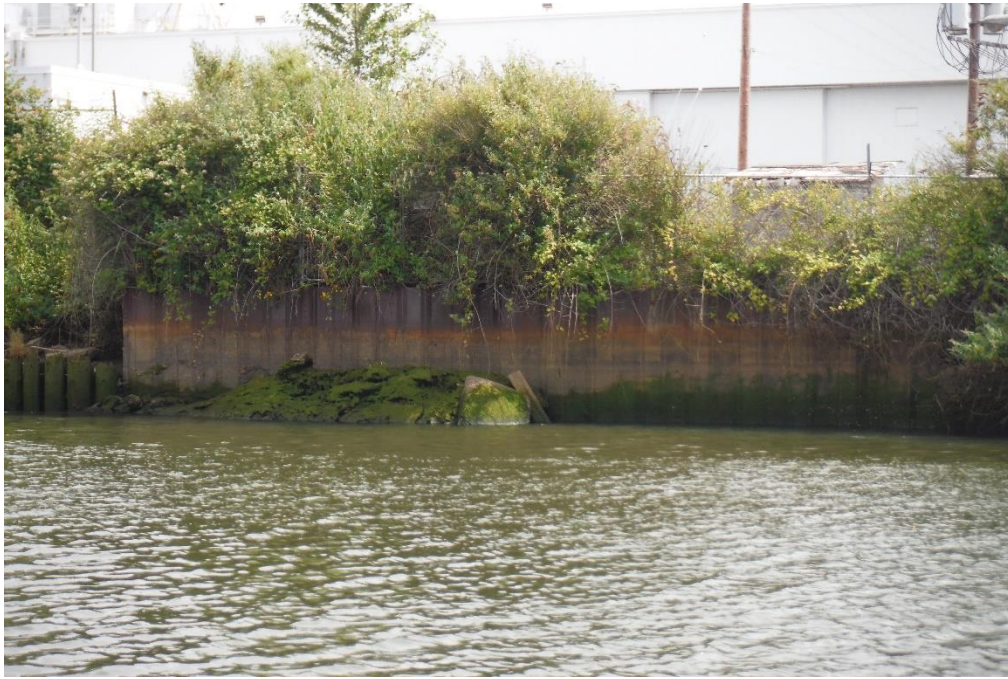
Photograph I-5
Representative Vegetation Conditions at RM 3.8W-d

3.8E-d	Top of bank	Sheetpile wall	BUDA	50	Vegetated top of bank is only 5 to 10 ft deep
			RUAR	40	
			BEPA	5	
			POBA	5	
	Middle of bank	Sheetpile wall	-	-	No vegetation

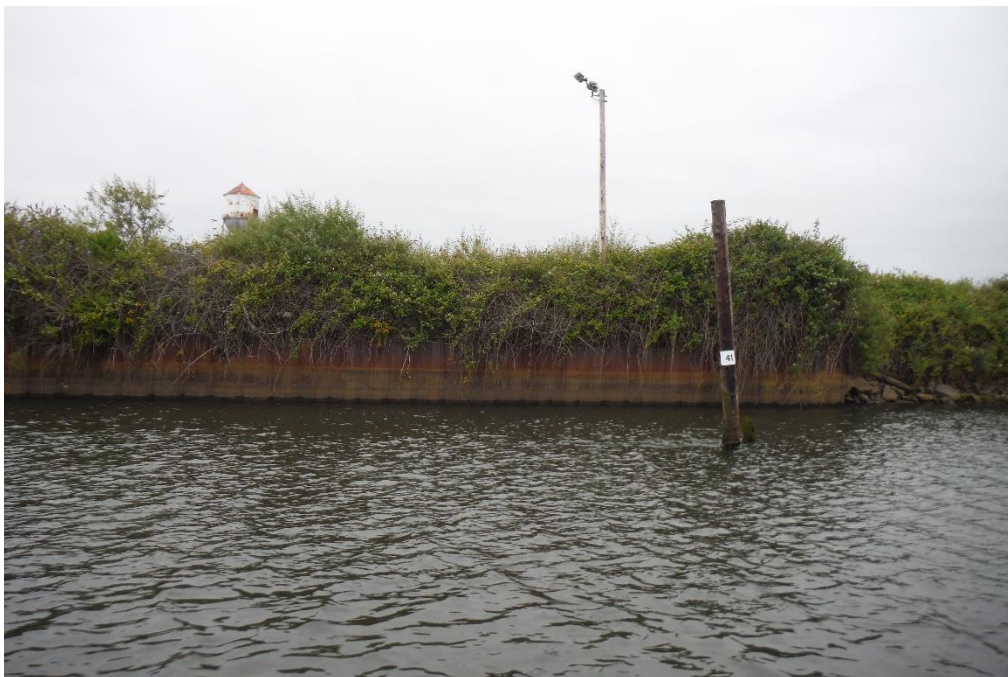
Photograph I-6
Representative Vegetation Conditions at RM 3.9E

3.9E	Toe of bank	Rock, gravel, and fines	-	-	No vegetation
	Top of bank	Sheetpile wall	BUDA	90	Vegetated top of bank is only 5 to 10 ft deep
			RUAR	10	
	Middle to bank	Sheetpile wall	-	-	No vegetation

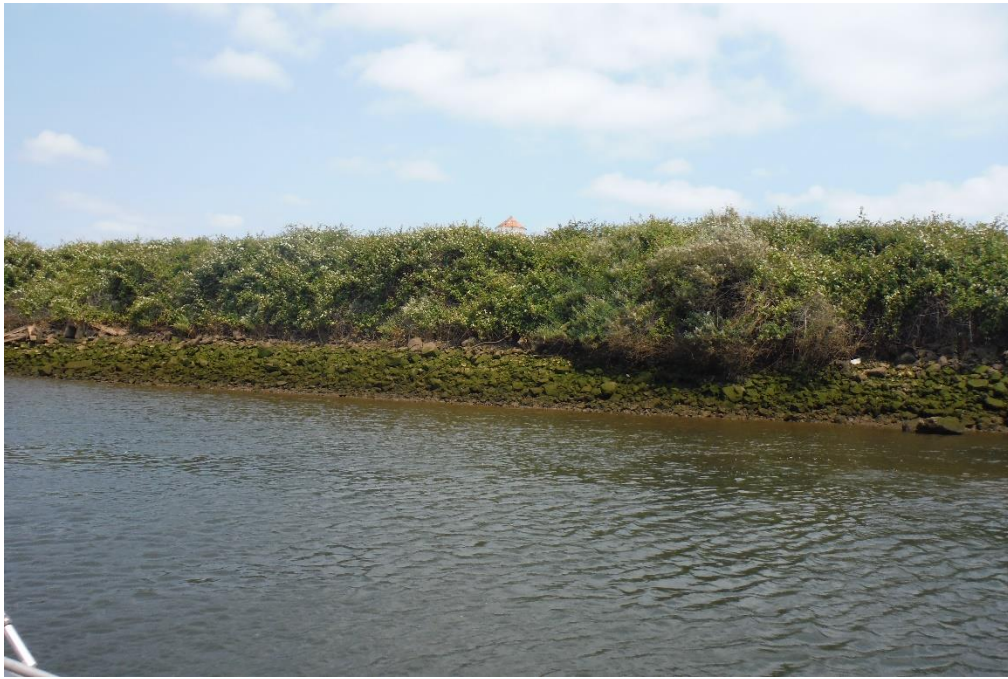
Photograph I-7
Representative Vegetation Conditions at RM 4.0E

4.0E	Top of bank	Medium riprap	RUAR	75	Vegetated top of bank is only 5 to 10 ft deep
			BUDA	24	
	Middle of bank	Medium riprap	RUAR	50	Dense shrubs
			BUDA	40	
			LELA	10	
	Toe of bank	Riprap	-	-	Algal mat on riprap

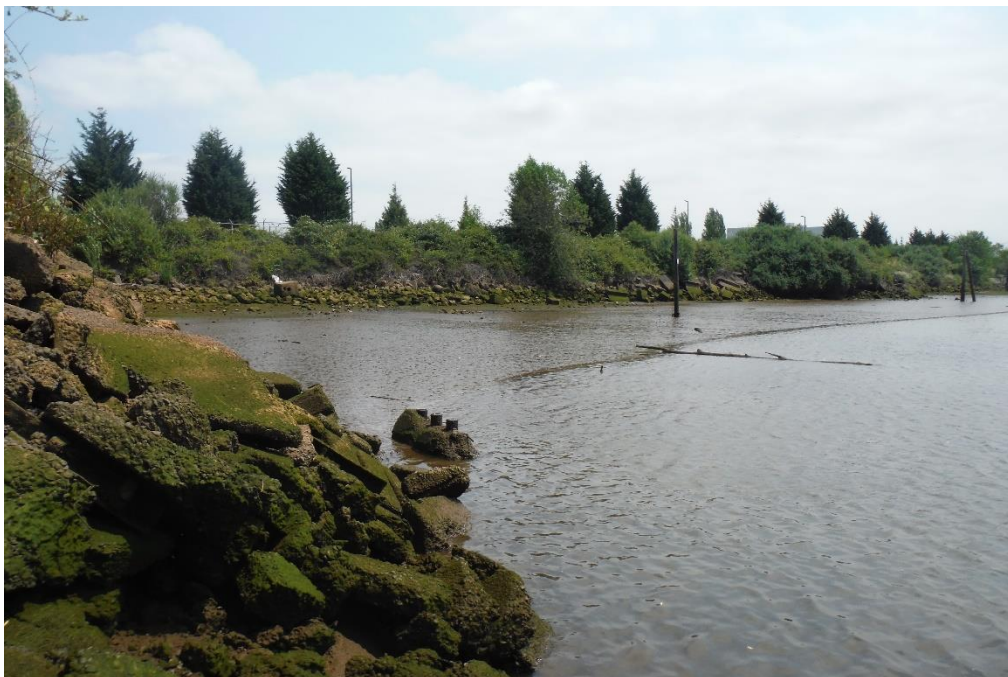
Photograph I-8
Representative Vegetation Conditions at RM 4.1E

River Mile ¹	Location Along Bank	Substrate/ Structure	Species	%	Notes
4.1E	Top of bank	Riprap, concrete debris, and fill	BUDA	45	Vegetated layer extends east 20 to 30 ft from top of bank. There is a canopy, shrub, and herb layer.
			FRLA	5	
			POBA	5	
			CULE	5	
			RUAR	10	
			RULA	5	
			HEHE	10	
			HYPE	5	
			PONI	10	
	Middle of bank	Riprap, concrete debris, and fill	RUAR	30	Mix of riprap and debris
			RULA	20	
			PONI	5	
			FRLA	5	
			LELA	5	
			LASE	5	
	Toe of bank	Loose riprap, rock, gravel, sands, and fines	BUDA	30	
			RUOC	10	Substrate is mix of fill and fines (50/50)
			IRPS	5	
			ALPL	5	
			POPA	5	
			SYLA	5

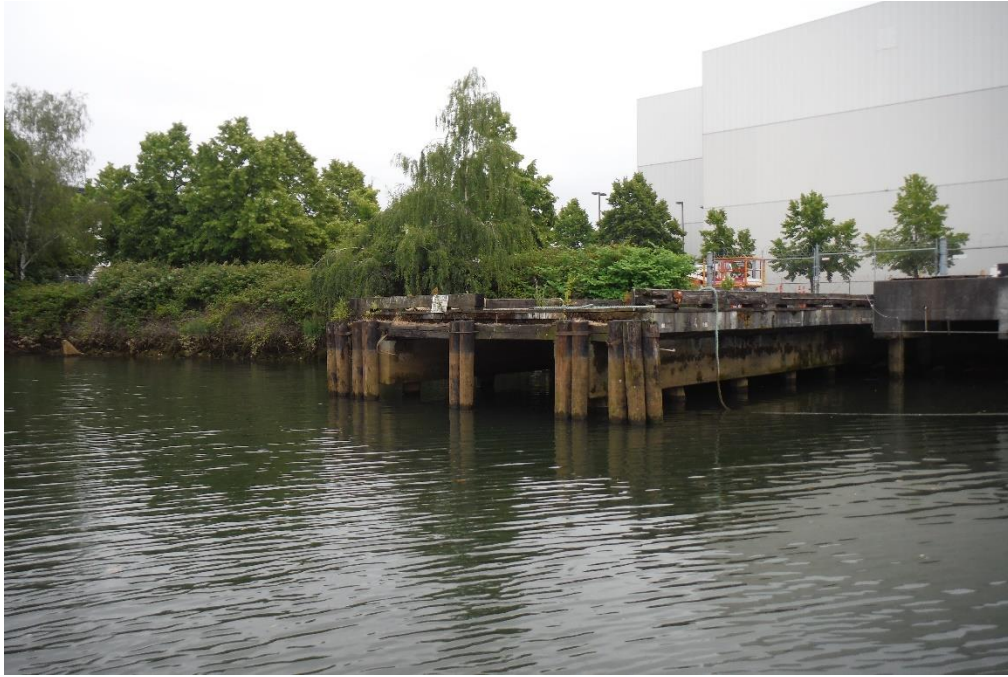
Photograph I-9
Representative Vegetation Conditions at RM 4.2E

4.2E (Slip 6)	Top of bank	Elevated pier	-	-	No vegetation
	Middle of bank	Open	-	-	No vegetation
	Toe of bank	Deepwater	-	-	No vegetation
4.6E	Top of bank	Parking lot bulkhead, riprap, and concrete slabs	BUDA	80	Very dense vegetation
			RUAR	20	
	Middle of bank	Riprap with 40%	BUDA	100	Very dense vegetation
	Toe of bank	Rock, gravel, and fines	-	-	No vegetation

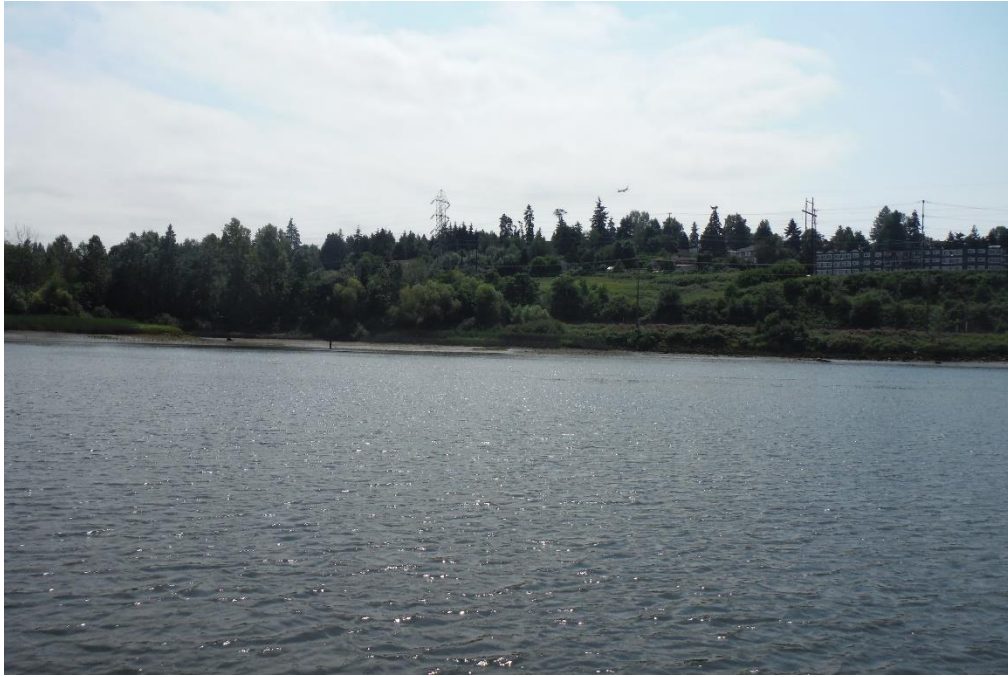
Photograph I-11
Representative Vegetation Conditions at RM 4.7W

4.7W	Top of bank	Native substrate	ALRU	40	Native substrate and vegetation
			BEPA	20	
			SASC	15	
			HOBI	10	
			PHAR	10	
			COSI	5	
	Middle of bank	Gravel, sand, and silt	TYLA	20	Native substrate and vegetation
			SCVA	20	
			CALY	40	
	Toe of bank	Silt	SCVA	10	Algal mat in depressions, piles in the nearshore
			CALY	10

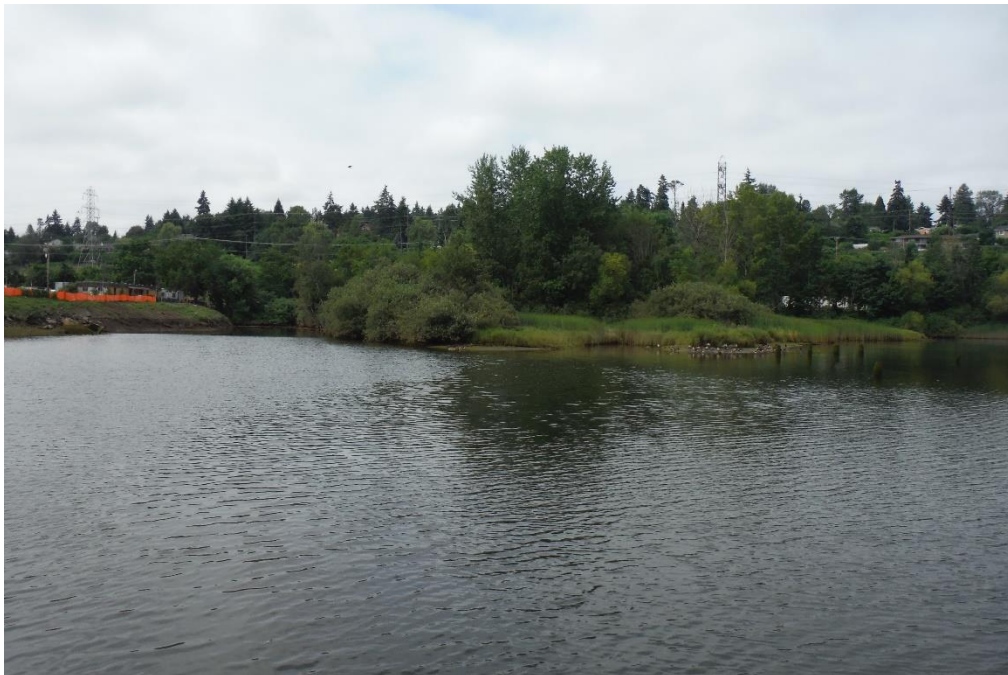
Photograph I-12
Representative Vegetation Conditions at RM 4.8W

River Mile ¹	Location Along Bank	Substrate/ Structure	Species	%	Notes
4.8W	Top of bank	Native substrate	ALRU	20	Native substrate and vegetation
			BEPA	20	
			SASC	10	
			HODI	5	
			PHAR	40	
			COSI	5	
	Middle of bank	Gravel, sand, and silt	TYLA	5	Native substrate and vegetation
			PHAR	20	
			SCVA	20	
			CALY	40	
	Toe of bank	Silt	SCVA	10	Algal mat in depressions, piles in the nearshore
			CALY	10

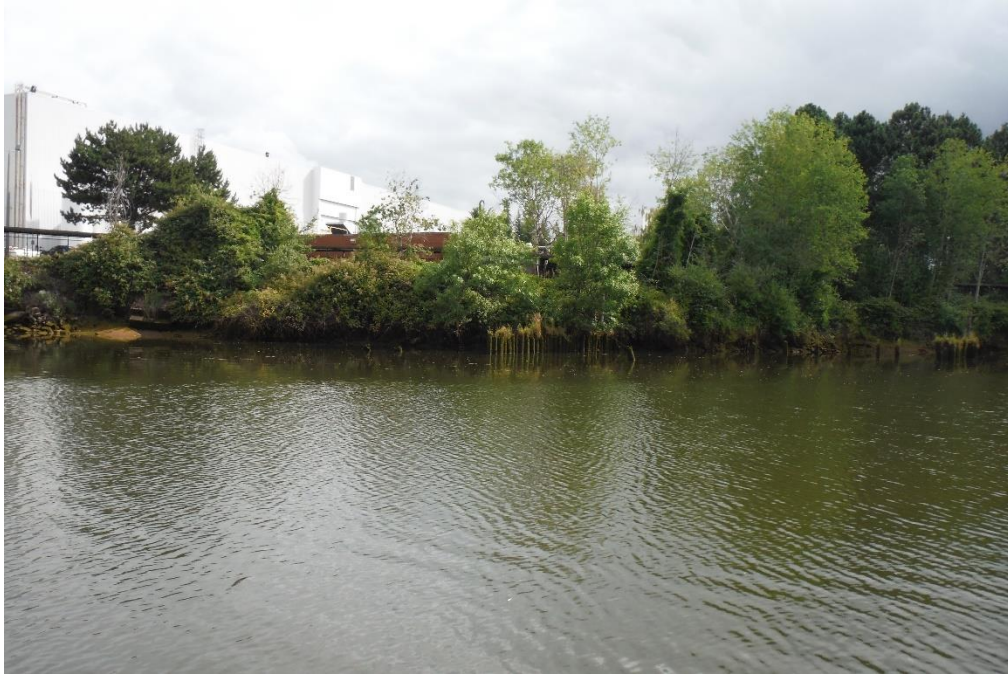
Photograph I-13
Representative Vegetation Conditions at RM 4.9E-a

4.9E-a	Top of bank	75% riprap, 25% concrete blocks	PICO	5	Mix of trees and shrubs extending to paved trail
			RUAR	25	
			POTR	30	
			BUDA	20	
	Middle of bank	Some riprap with exposed soil	FRLA	10	Scattered trees and saplings
			RUAR	60	
			BUDA	20	
	Toe of bank	Piles, riprap, gravels, and fines	SYLA	10	Aster rooted in the piles

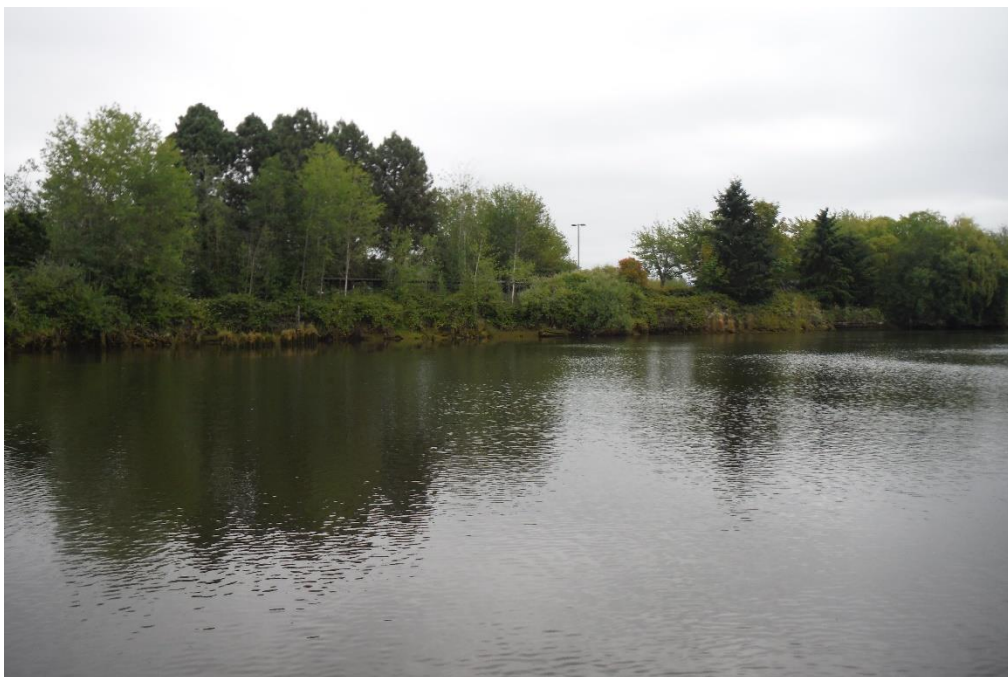
Photograph I-14
Representative Vegetation Conditions at RM 4.9E-b

4.9E-b	Top of bank	25% riprap, 25% steep soil	PICO	20	Mix of trees and shrubs
			RUAR	25	
			POTR	50	
			FRLA	5	
	Middle of bank	Soil with rock	RUAR	50	-
	Toe of bank	Piles, riprap, gravel, and fines	SYLA	5	Aster rooted in piles, algal mat on riprap
			JUEF	5	
			IRPS	10	
			POPA	10

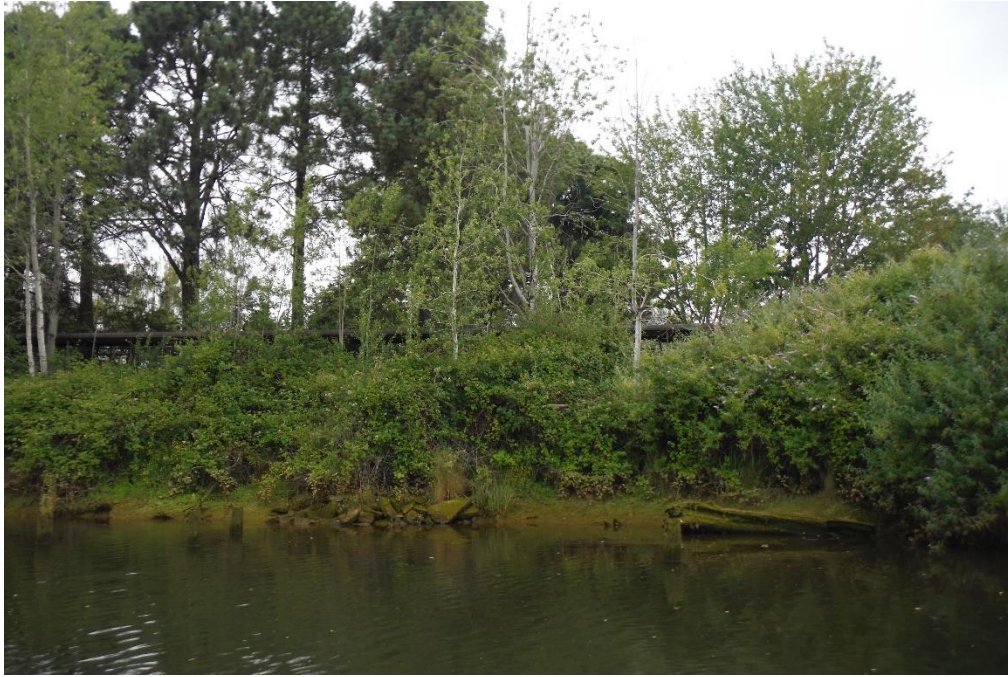
Photograph I-15
Representative Vegetation Conditions at 4.9E-c

4.9E-c	Top of bank	75% soil, 20% riprap, 5% piles	PSME	25	-
			ACMA	40	
			RUAR	25	
	Middle of bank	Steep exposed soil	RUAR	40	
			LELA	10	
			HYPE	10	
	Toe of bank	High tide bench with piles	IRPS	5	
			POPA	10

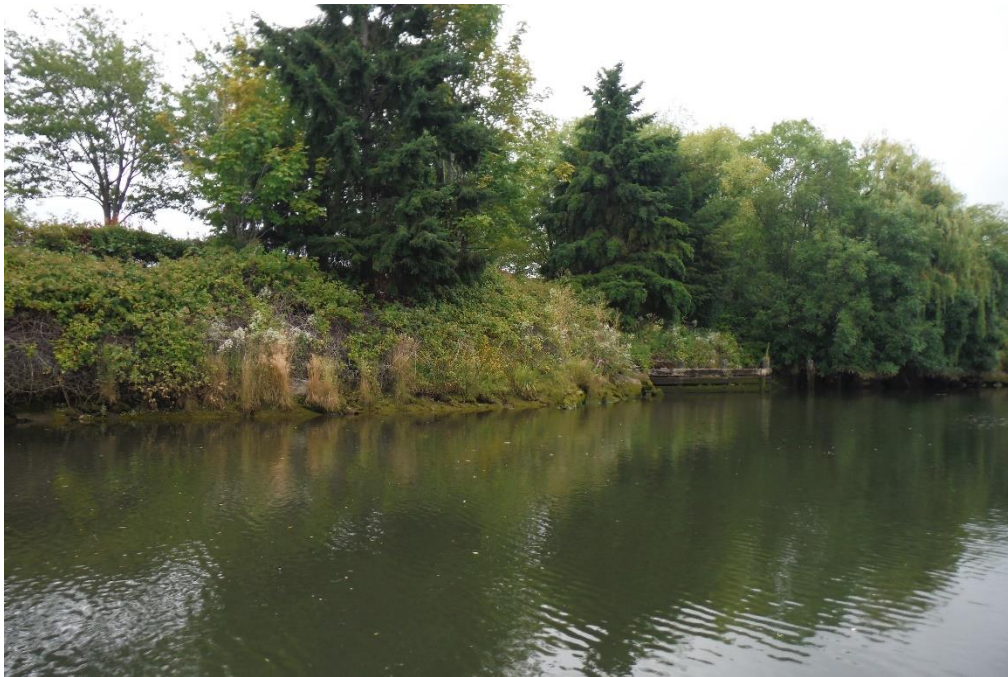
Photograph I-16
Representative Vegetation Conditions at RM 4.9E-d

4.9E-d	Top of bank	Concrete slabs and large riprap	ALPL	5	Large debris
			SALA	50	
	Middle of bank	Concrete slab and large riprap	FRLA	50	80% bare ground
			RUAR	20	
	Toe of bank	Concrete slab and large	BUDA	5	Algal mat on riprap
			CALY	5	
			SYLA	5
